## BODY INTERIOR

### BODY INTERIOR

KORANDO 2013.08

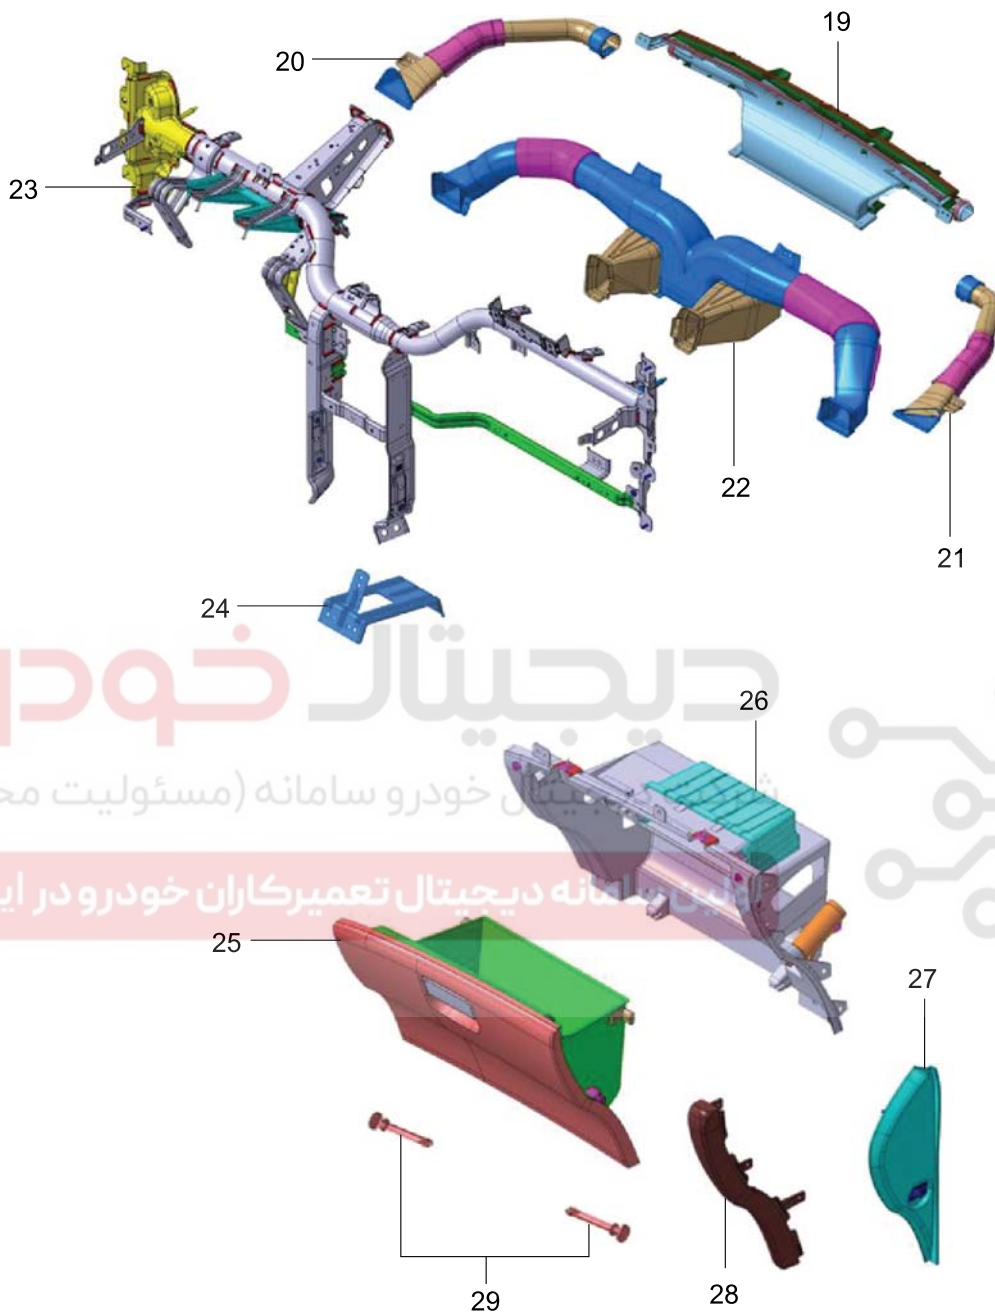
## 7611-00 INSTRUMENT PANEL

19.Defroster center nozzle  
20.LH defroster side mirror  
21.RH defroster side mirror  
22.Main duct  
23.Instrument panel frame  
24.RH crash pad bracket

25.Glove box  
26.Glove box housing  
27.RH crash pad side cover  
28.RH glove box housing extension  
29.Retainer pin

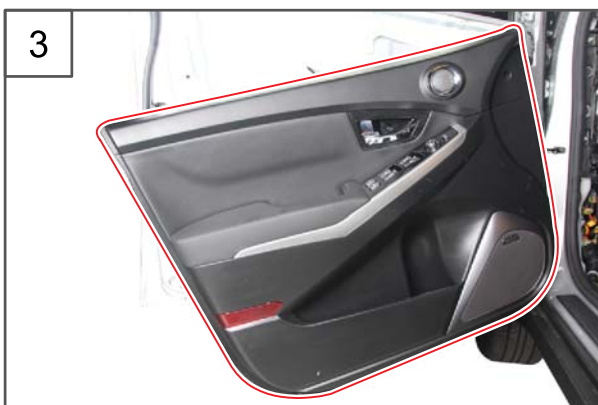
3. Carefully pry off the front door trim making sure not to damage the clips (9 positions).

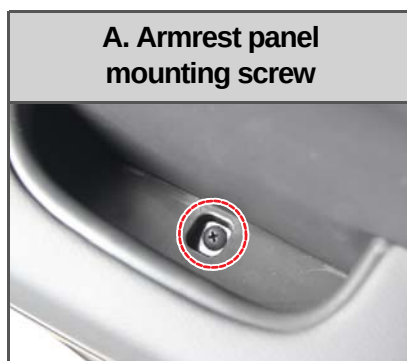
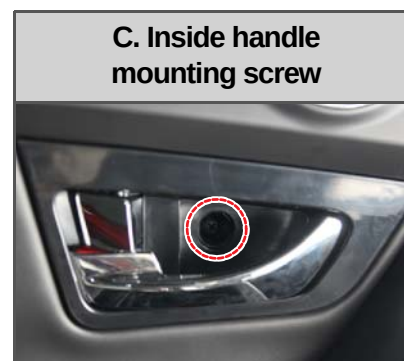
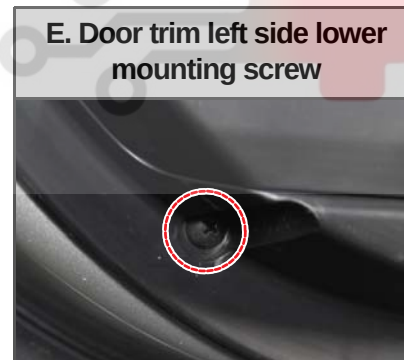
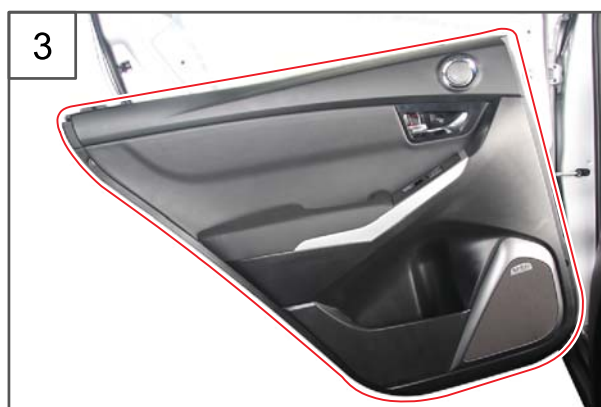
2. Remove the mountings from the rear door trim.

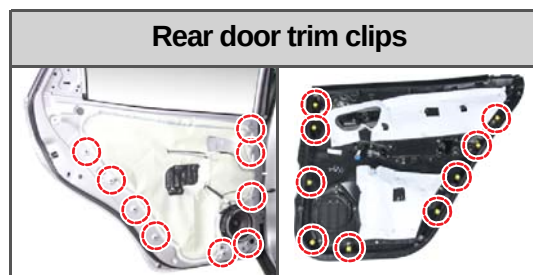
3. Carefully pry off the rear door trim making sure not to damage the clips (9 positions).

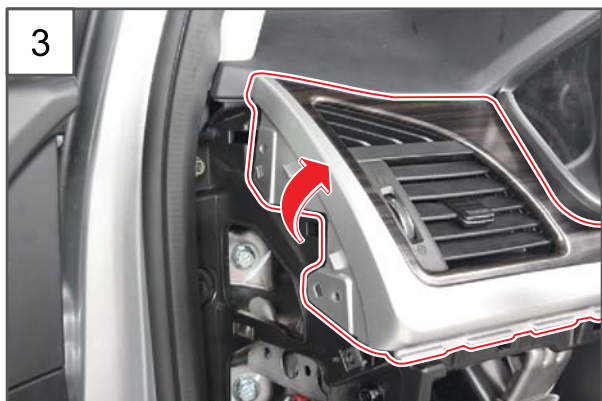
3. Carefully pry off the LH side fascia panel. Take care not to damage the clips (4 positions).

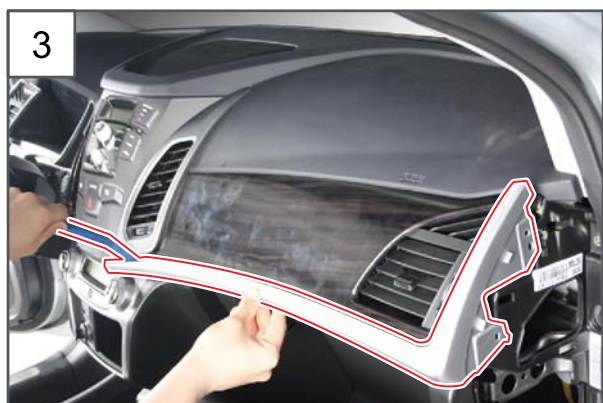
3. Pry off the part A to remove the RH side fascia molding. Take care not to damage the clips (8 positions).

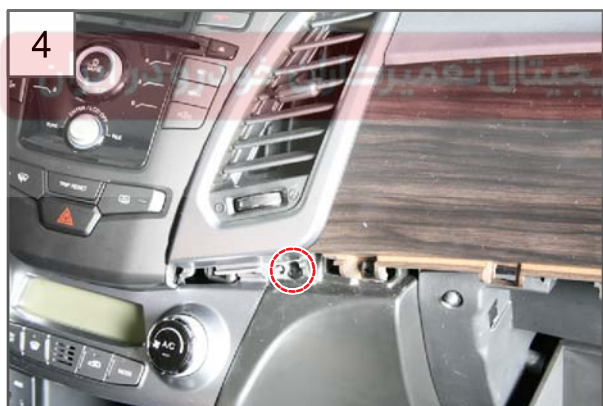
4. Unscrew the RH center fascia panel mounting screw.

5. Carefully pry off the RH center fascia panel. Take care not to damage the clips (3 positions).

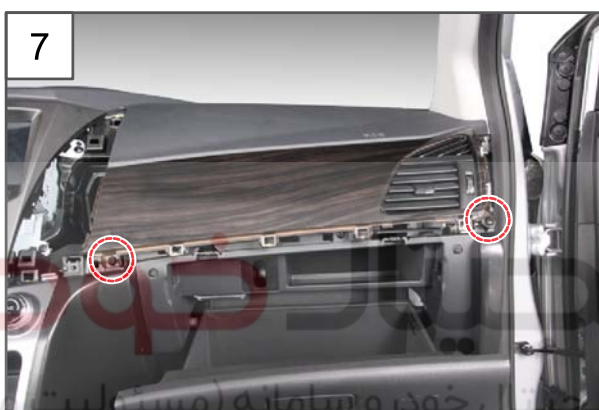
7. Unscrew the 2 mounting screws and carefully pry off the RH side fascia panel. Take care not to damage the clips (9 positions).

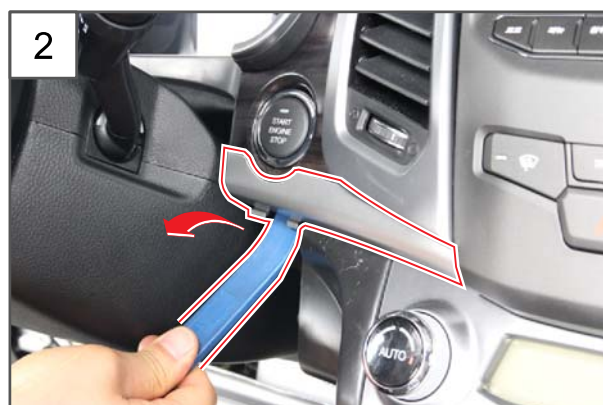
2. Carefully pry off the center fascia molding making sure not to damage the clips (2 positions).

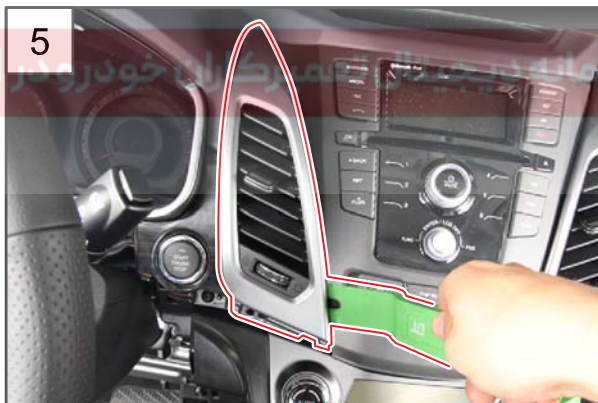
5. Carefully pry off the LH center fascia panel making sure not to damage the clips (3 positions).

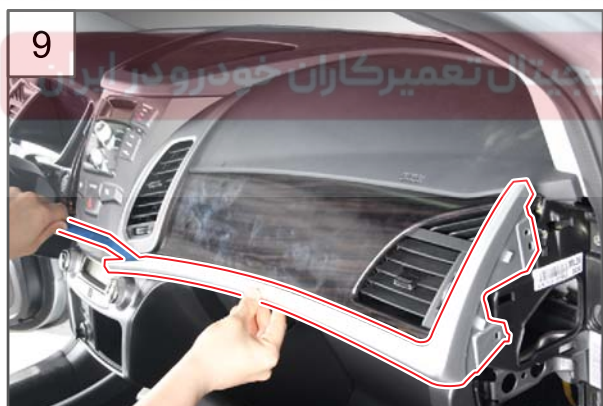
9. Pry off the part A to remove the RH side fascia molding. Take care not to damage the clips (8 positions).

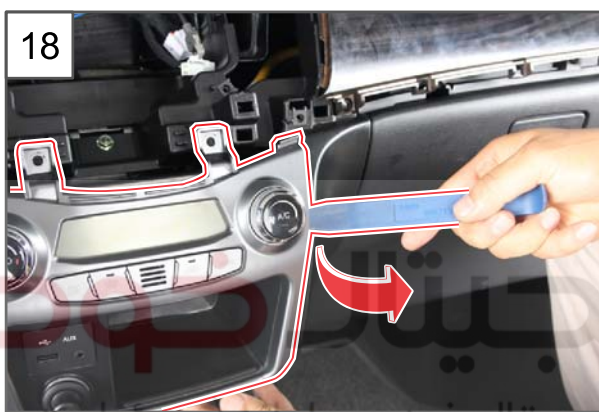
18. Carefully remove the center fascia lower panel assembly making sure not to damage the clips (4 positions).

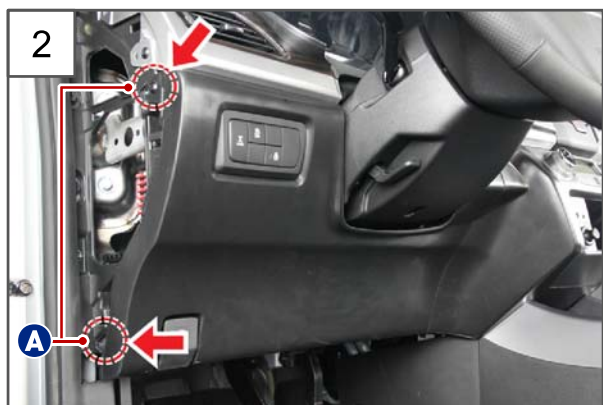
2. Unscrew the 2 mounting screws (A) and carefully pry off the lower main panel. Take care not to damage the clips (6 positions).

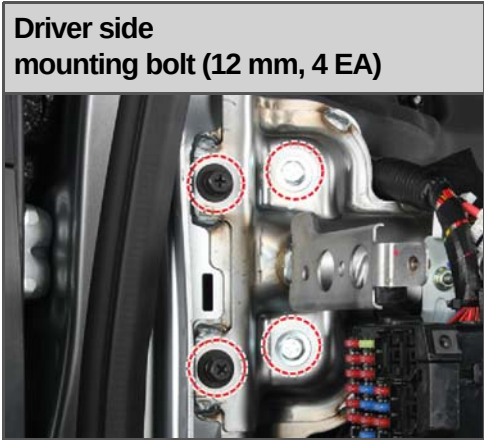
17.Remove the mountings securing the instrument panel to the air conditioner module and vehicle body.
